CHARACTERIZATION OF FATIGUE BEHAVIOR  
OF 2-D WOVEN FABRIC REINFORCED  
CERAMIC MATRIX COMPOSITE  
AT ELEVATED TEMPERATURE

THESIS

Daniel J. Groner, Captain, USAF

AFIT/GAE/ENY/94D-15

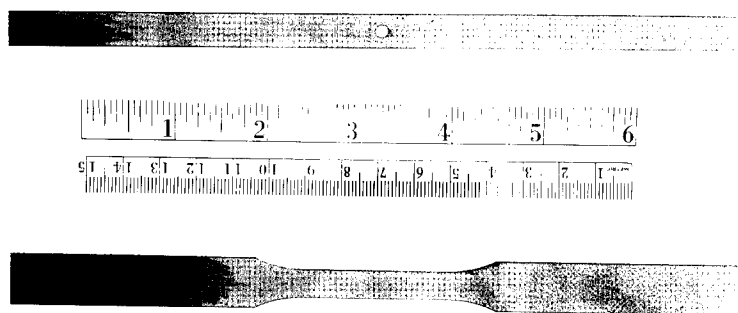
Figure 1-1 SiC/SiC specimens Prior to Testing.

The specimens, used in this work (see Figure 1-1), were produced by DuPont Lanxide Composites Inc. The un-notched specimens had a dog-bone geometry to ensure the failure in the center portion away from the grips. The notched specimens had a centrally located circular hole with a diameter to specimen width ratio ( $D/W$ ) of  $0.331 \pm 0.003$ .

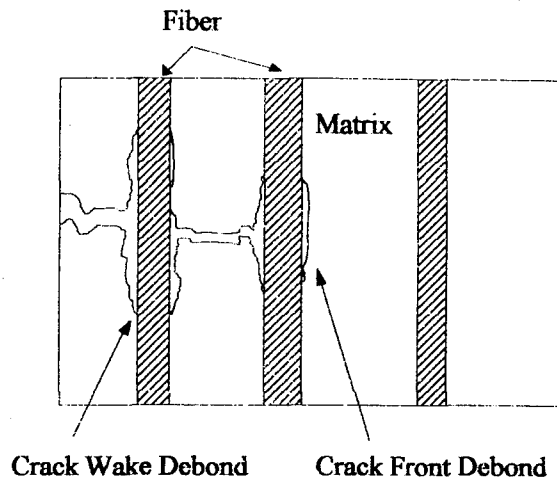
Figure 2-1 Fiber Debonding

Two failure modes are possible in CMC materials. First the fibers may be relatively weak and the interfacial bond relatively strong. This combination allows the matrix crack to penetrate through the fibers resulting in catastrophic failure of the material. The second failure mode arises from a material comprised of strong fibers and weak interfacial bonds. Here the matrix crack grows around the fiber as the fiber/matrix interface debonds both in front of and behind the

crack tip as shown in Figure 2-1. This is the desired failure mode because a matrix crack does not result in catastrophic failure making this the chosen path in CMC development[16].

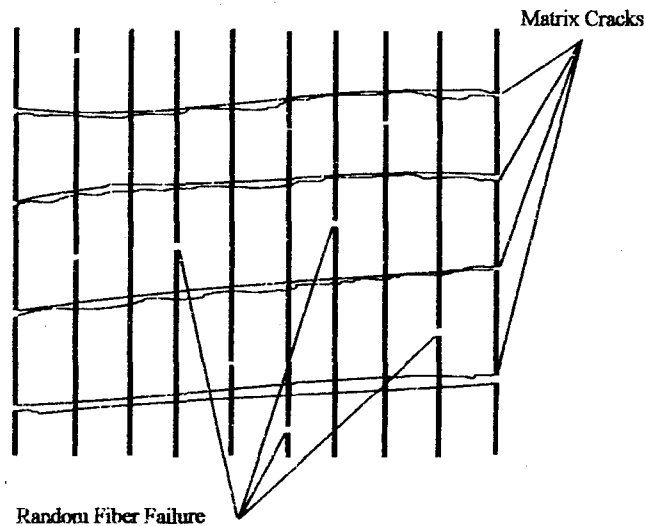
Figure 2-2 Multiple Matrix Cracking

Three major mechanisms of toughness and strengthening are present in CMC materials. The first is multiple matrix cracking which is illustrated schematically in Figure 2-2. Multiple fracture analysis was proposed by Aveston, Cooper, and Kelley (ACK theory)[1]. They used energy balance to relate strength of the microstructure to fiber reinforcement. The second toughening mechanism is crack impediment. Crack bowing originates from the second phase particles in the path of a propagating crack[9]. The crack tends to bow between the second phase particles until the fracture toughness of the particles is reached. This bowing causes the stress intensity

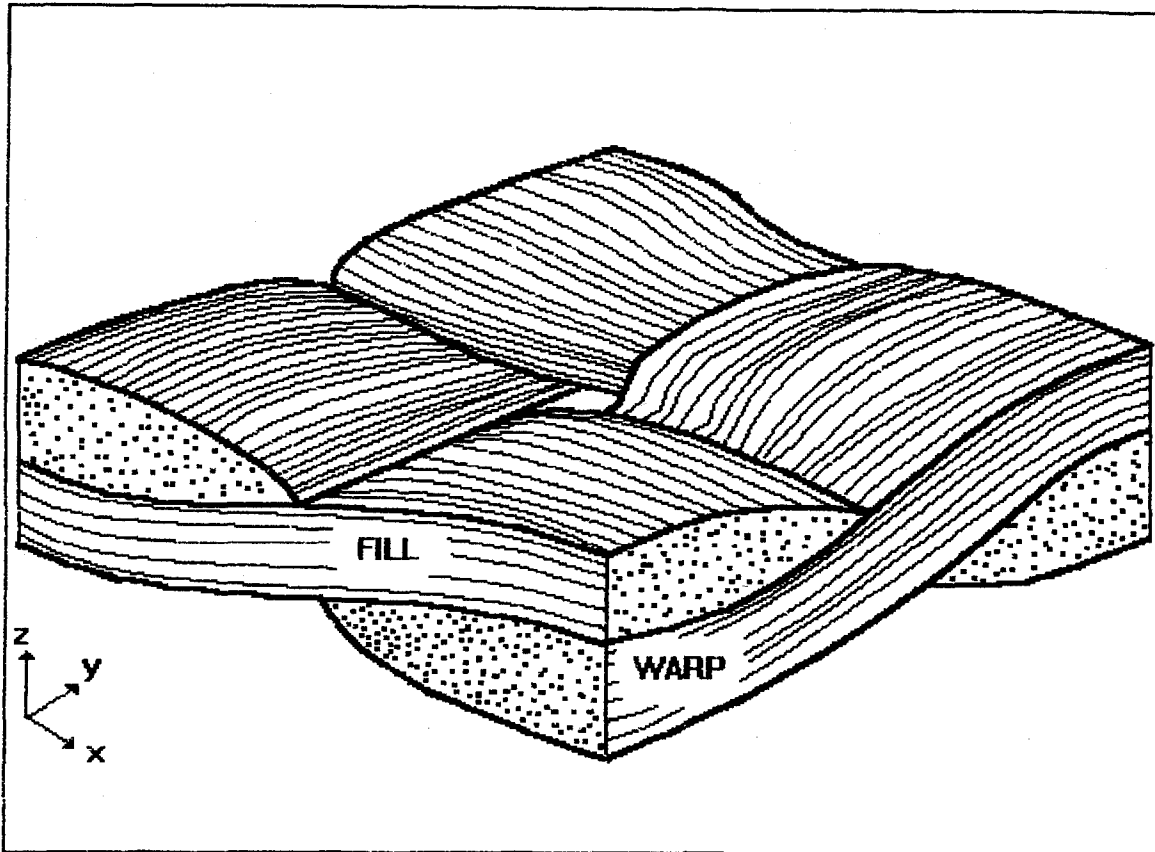
Figure 2-3 Woven Fabric Composite Reinforcement Structure

In the 2-D woven fabric composite the "0" and "90" yarns are interlaced in each ply as shown in Figure 2-3. Composites

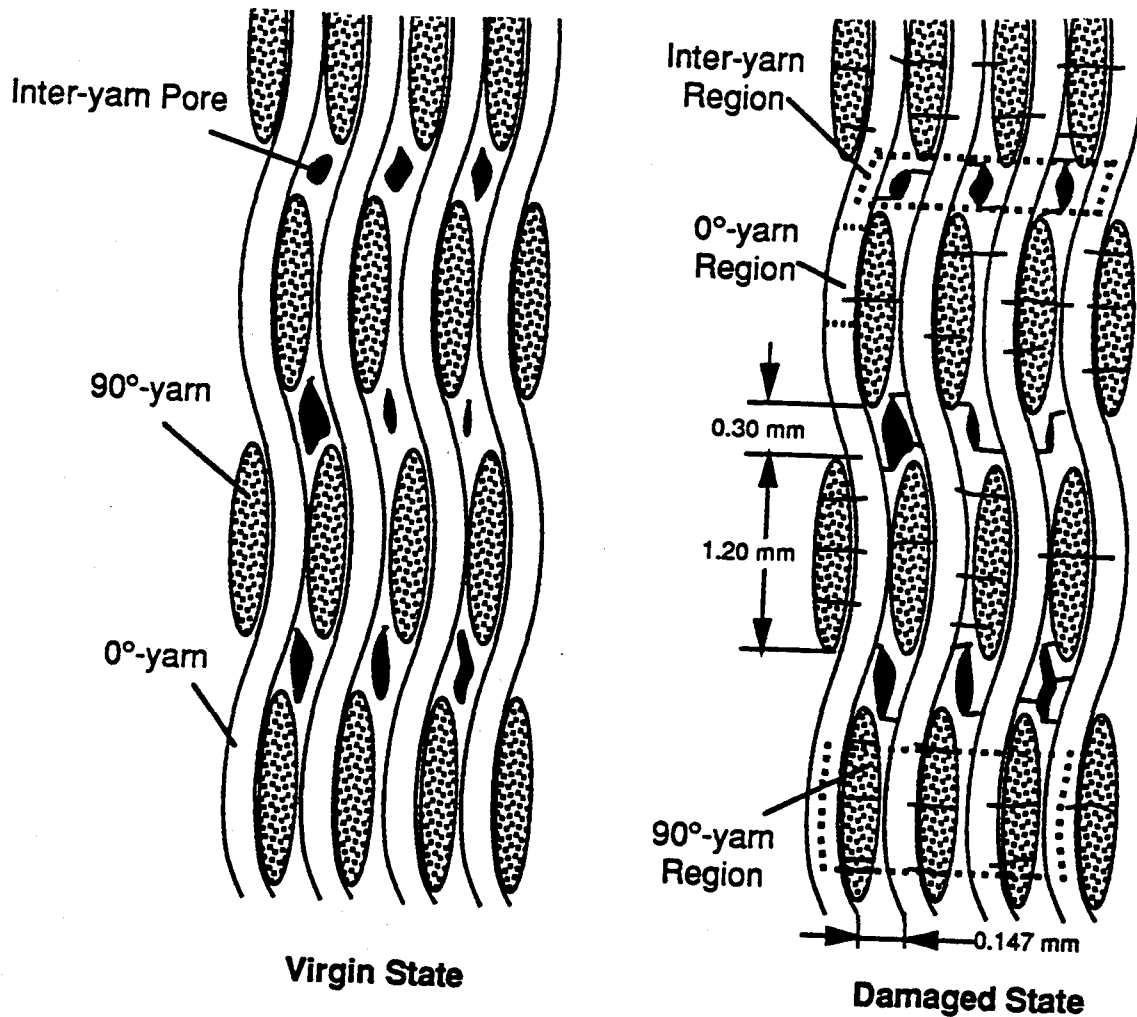
Figure 2-4 Schematic of Virgin and Damaged States in Woven Composite

with this type of reinforcement structure are known as textile composites. Chen has studied the enhanced SiC/SiC CMC under room and elevated temperature monotonic tensile conditions and reports damage progression as follows[4]. When stressed in tension initial damage takes place in the inter-yarn region; that is, the porous matrix between the warp ( $90^\circ$ ) and fill ( $0^\circ$  or weft) yarns, Figure 2-4. This damage initiates at the 84 MPa load level during  $1200^\circ\text{C}$  tests. Stress strain behavior beyond this point is not linear; therefore, this 84 MPa stress level denotes the proportional limit. As the stress level

approaches 150 MPa, the matrix of the 90° yarns begins to crack. These cracks propagate and some penetrate into the 0° yarn region. At this stress level interface debonding takes

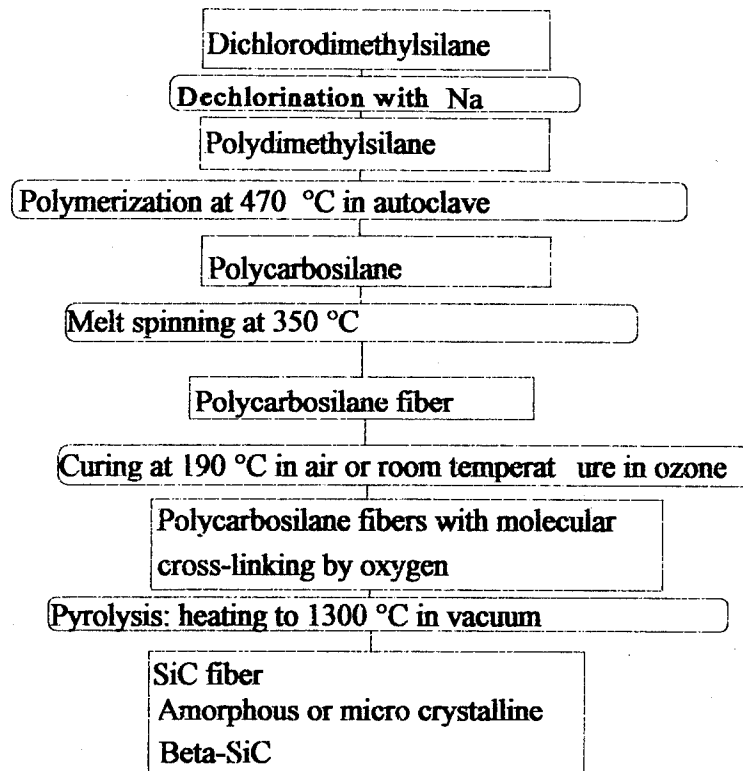
Figure 3-1 Schematic of Nicalon Manufacturing

fiber manufacturing process. The SiC fibers are spun into yarns and woven to form the fabric used in making the preform for the CVI process.

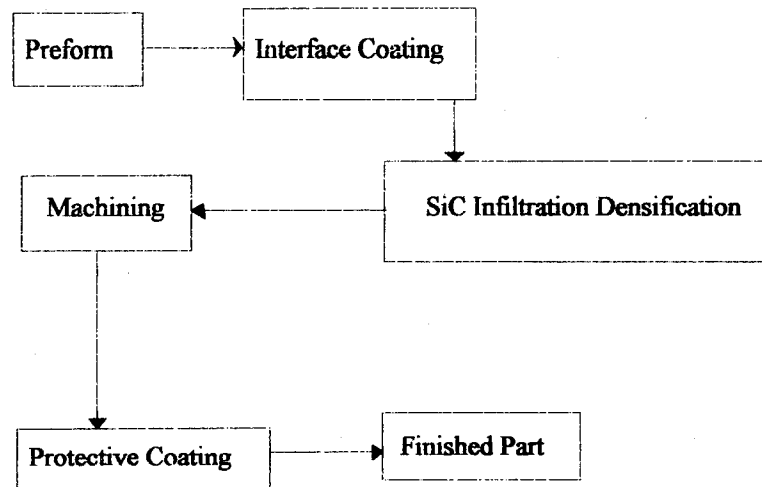
Figure 3-2 Production of CMC Component Using the CVI Process

radially around each fiber. Figure 3-2 schematically illustrates the CVI process used in the production of SiC/SiC.

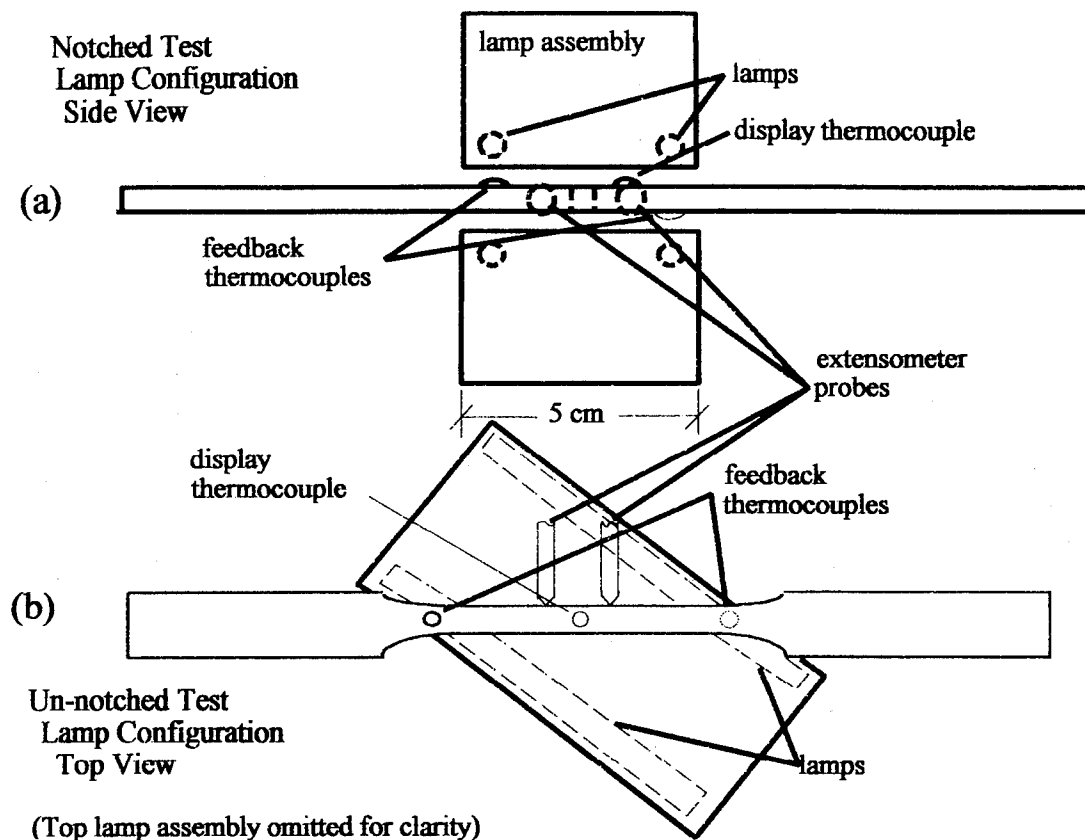
Figure 3-6 Heat Lamp Assembly Configuration

The first attempt to test an unnotched specimen used a perpendicular lamp configuration as used for the notched specimens. The lamp housing width was 5 cm and the

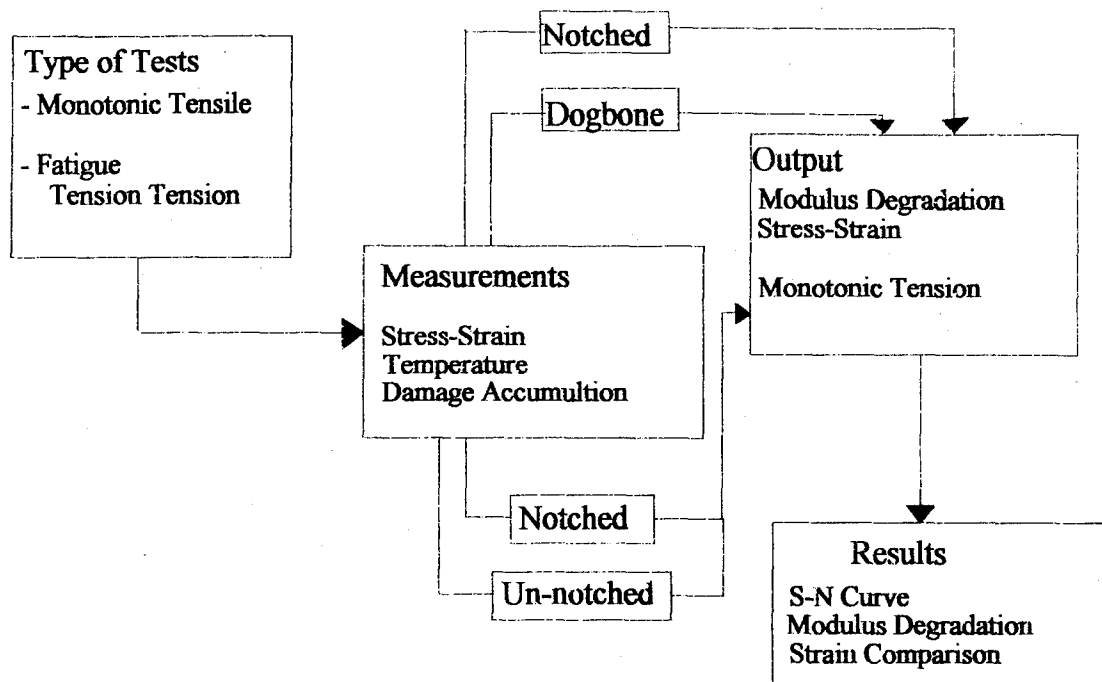
Figure 3-7 Schematic of Experimental Approach

The complete lay-out of the test procedure is shown in Figure 3-7. Seven notched specimens and five unnotched specimens were tested in tension-tension fatigue. These tests provided sufficient data points to establish the notched and unnotched S-N curves.

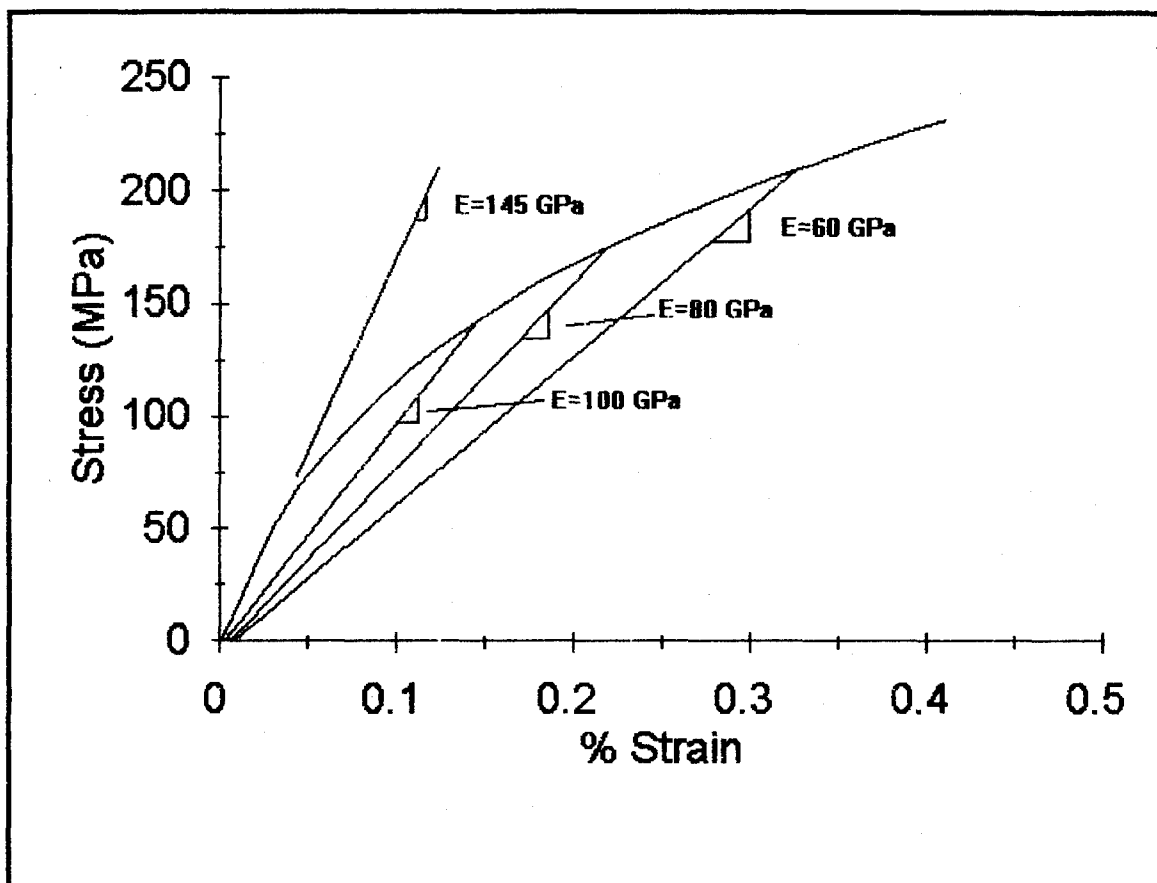
Figure 4-1 Unnotched Static Stress-Strain Curve

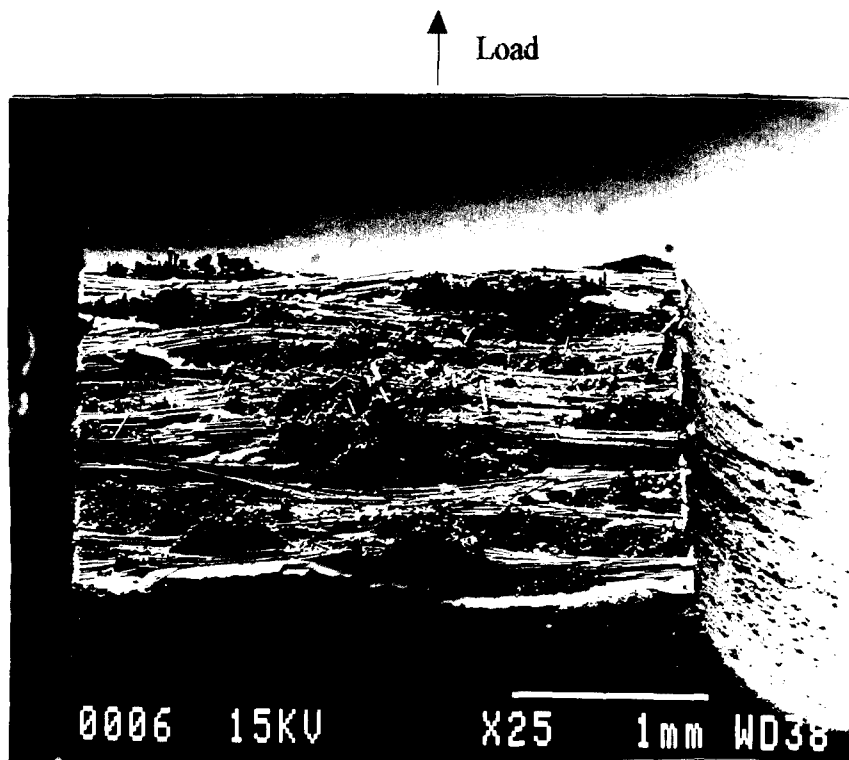
Figure 4-4 Notched Monotonic Tensile Fracture Surface, Scanning Electron Micrograph, 25X

The magnified fracture surface is shown in Figure 4-3 and a scanning electron micrograph of the fracture surface is presented in Figure 4-4. Note the jagged fracture surface and

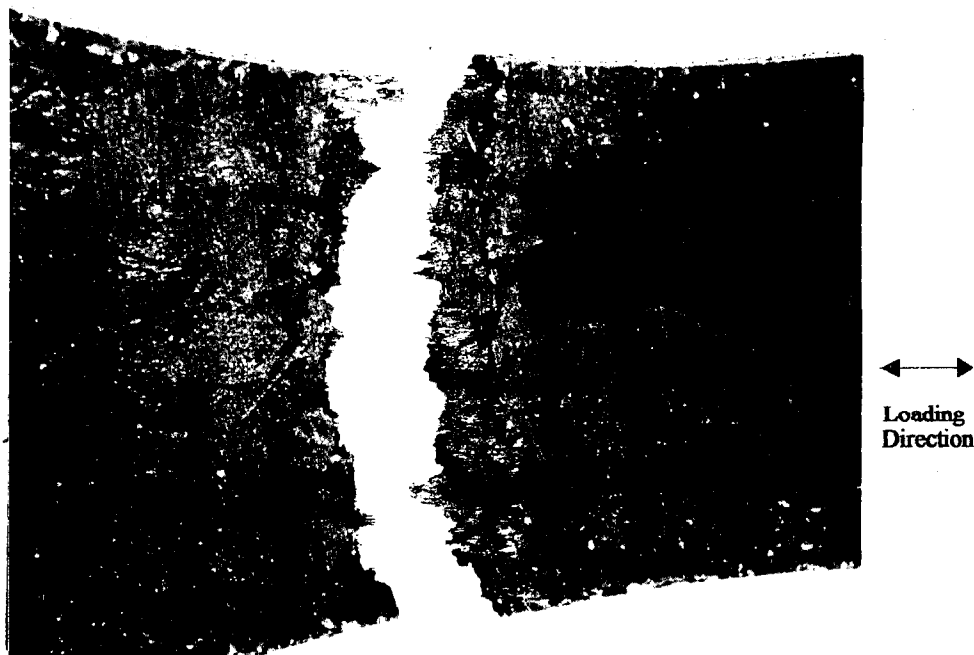
Figure 4-5 Fracture Surface, Top View,  
210 MPa Unnotched Test, 8X

The unnotched fatigue test with the highest tensile stress level was the 210 MPa test. It cycled 977 times before failure. A view of the fracture is presented in Figure 4-5. The 210 MPa test stress-strain curves at four specific cycles of the test are shown in Figure 4-6. The stress-strain behavior during the first cycle exhibited the same nonlinearity above the proportional limit as previously described for monotonic tensile testing; however, the stress strain curves of

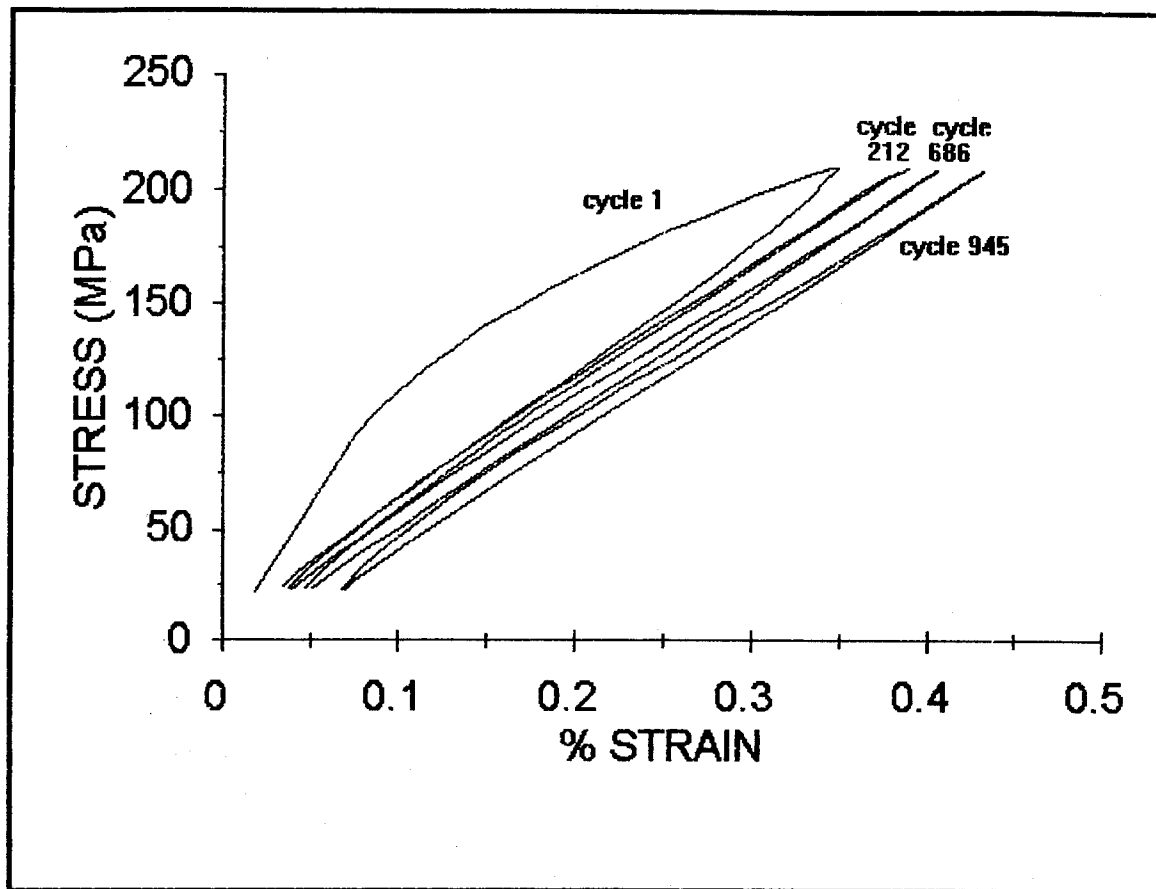
Figure 4-6 210 MPa Unnotched Stress-Strain Curves

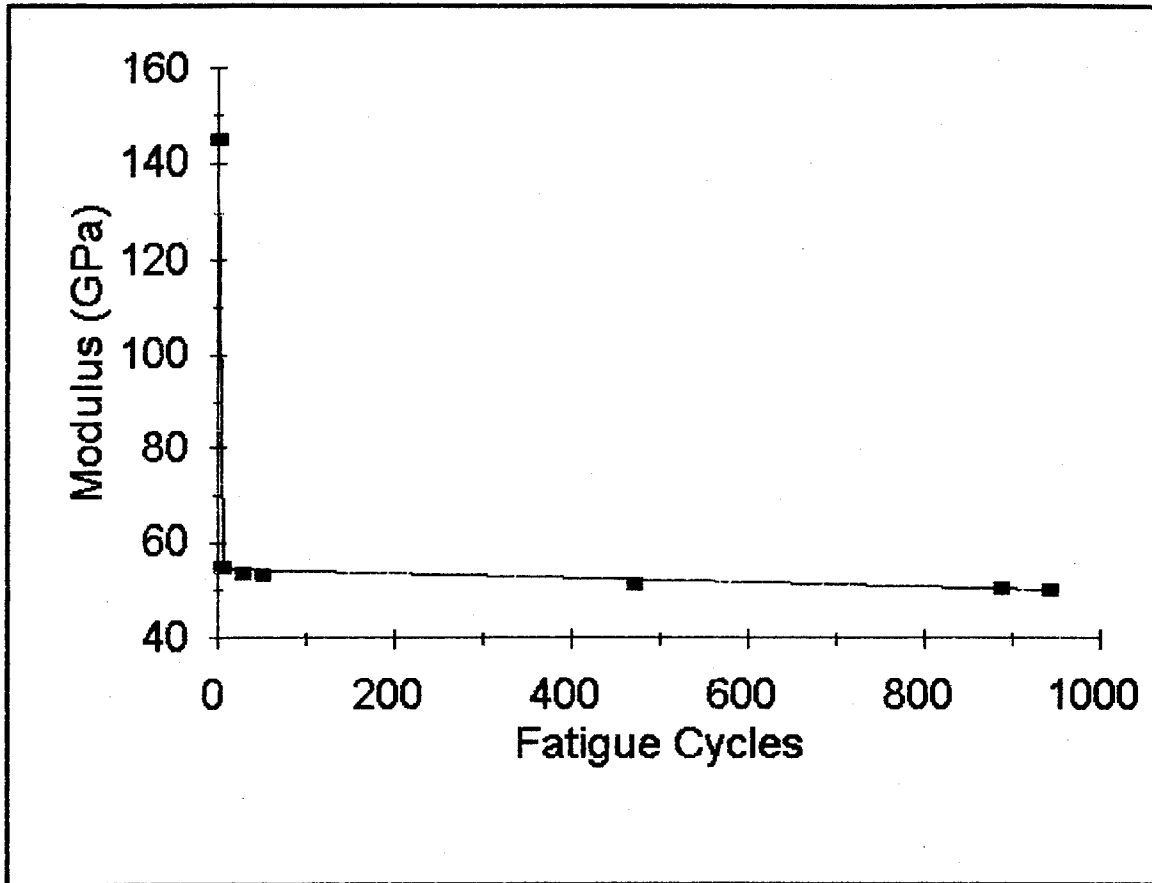
Figure 4-7 210 MPa Unnotched Modulus Reduction

The damage accrued and the modulus degraded slightly with further cycling as plotted in Figure 4-7. The first cycle

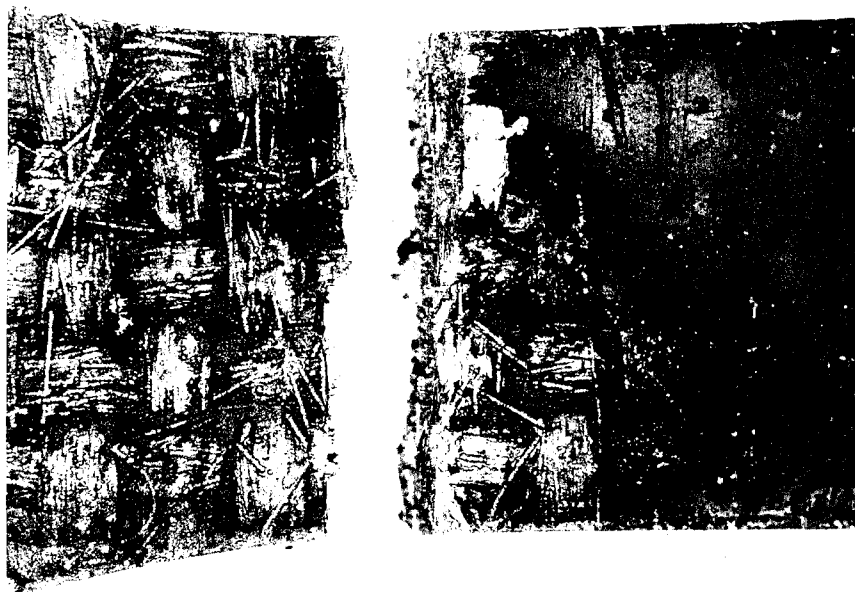
Figure 4-9 170 MPa Fracture Surface 8X

The first unnotched fatigue test at intermediate stress level was the 170 MPa test. It cycled 6,881 times before failure. A magnified view of the fractured specimen is shown in Figure 4-9. Note the slightly smoother fracture surface as opposed to the 210 MPa test (Figure 4-5).

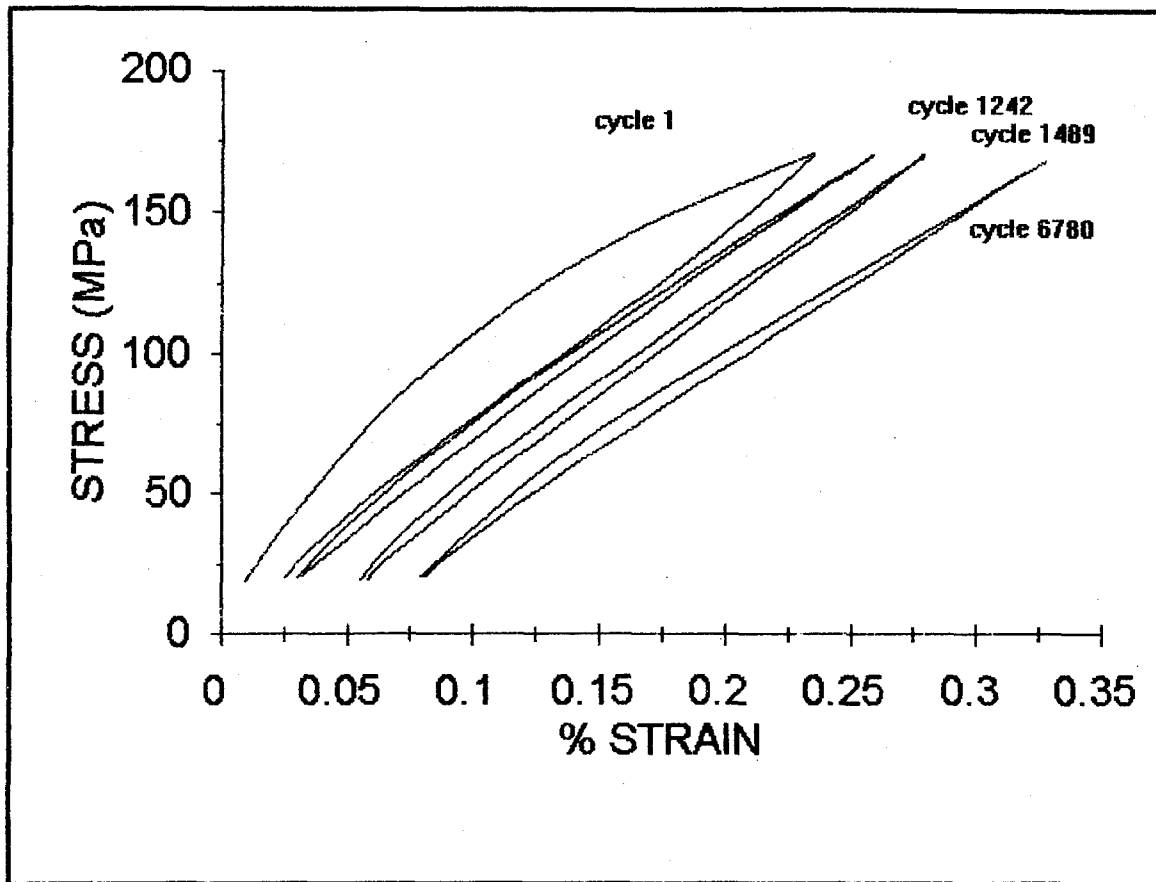
Figure 4-10 Stress-strain 170 MPa Unnotched Test

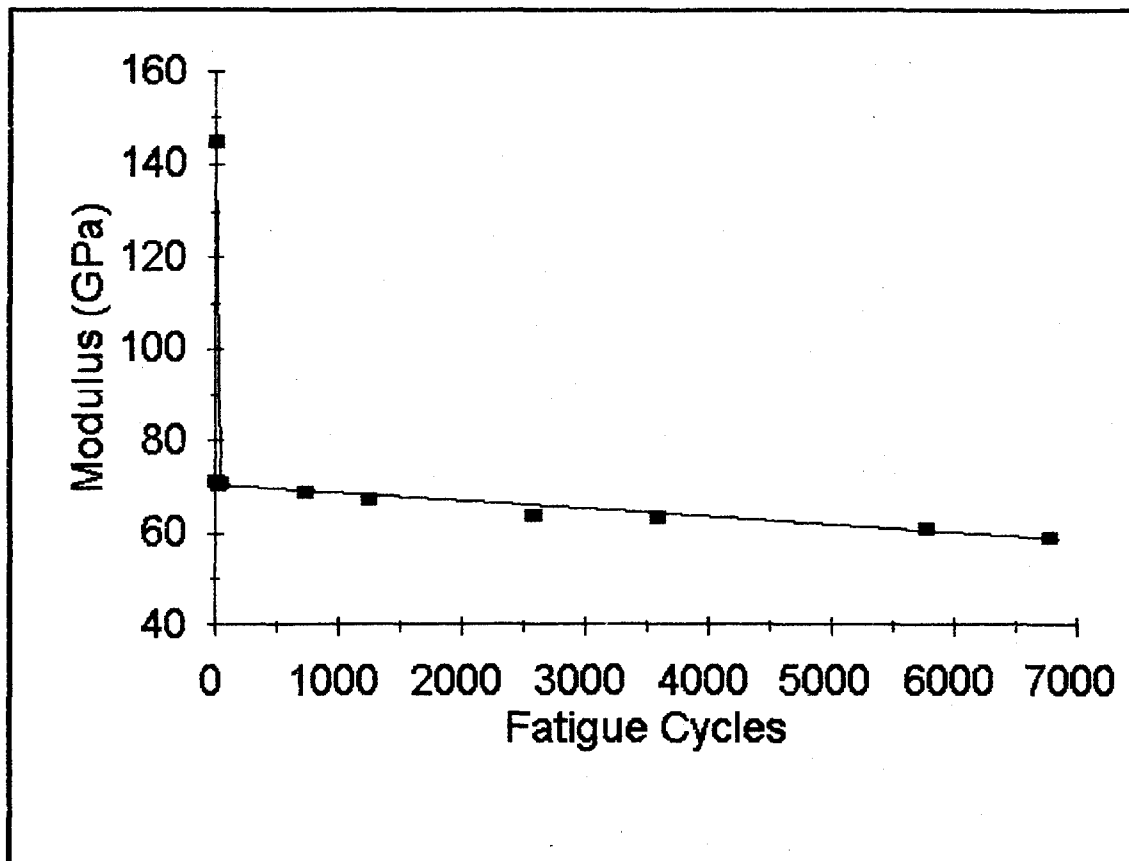
Figure 4-11 170 MPa Unnotched Modulus Reduction

Figure 4-11 shows the modulus reduction over the life of the 170 MPa unnotched fatigue test. This is further evidence of the microstructural damage taking place during the test.

Overall a modulus reduction of 52% is observed from the Young's modulus of the loading portion of the first cycle to the modulus of the third cycle in this test. The 80 GPa Young's modulus predicted by plotting a line to the 170 MPa stress level of the unnotched monotonic tensile test shows the good correlation with the 70 GPa displayed in this 170 MPa fatigue test. After the first cycle damage, indicated by the large initial reduction of modulus, further damage effects a constant rate modulus reduction over the life of the test until the specimen fails at a modulus of 60 GPa.

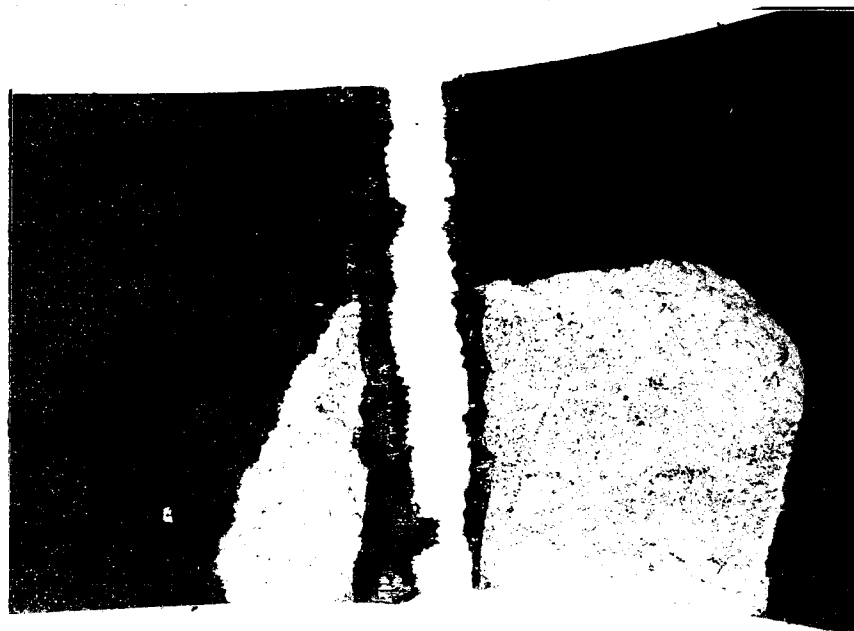
Figure 4-12 140 MPa Unnotched Failure Surface, 8X

The next fatigue stress level of unnotched test was the 140 MPa test. This specimen cycled 25,343 times before failure. A magnified view of the fracture is shown in Figure 4-12. Four stress-strain curves of the 140 MPa test are shown in Figure 4-13. The specimen's stress-strain response showed a slight progressive increase in nonlinearity which is most likely attributable to the progression of multiple matrix micro-cracking and fiber pullout. Residual strain increased in magnitude over the life of the test indicating some micro-structural damage accumulation.

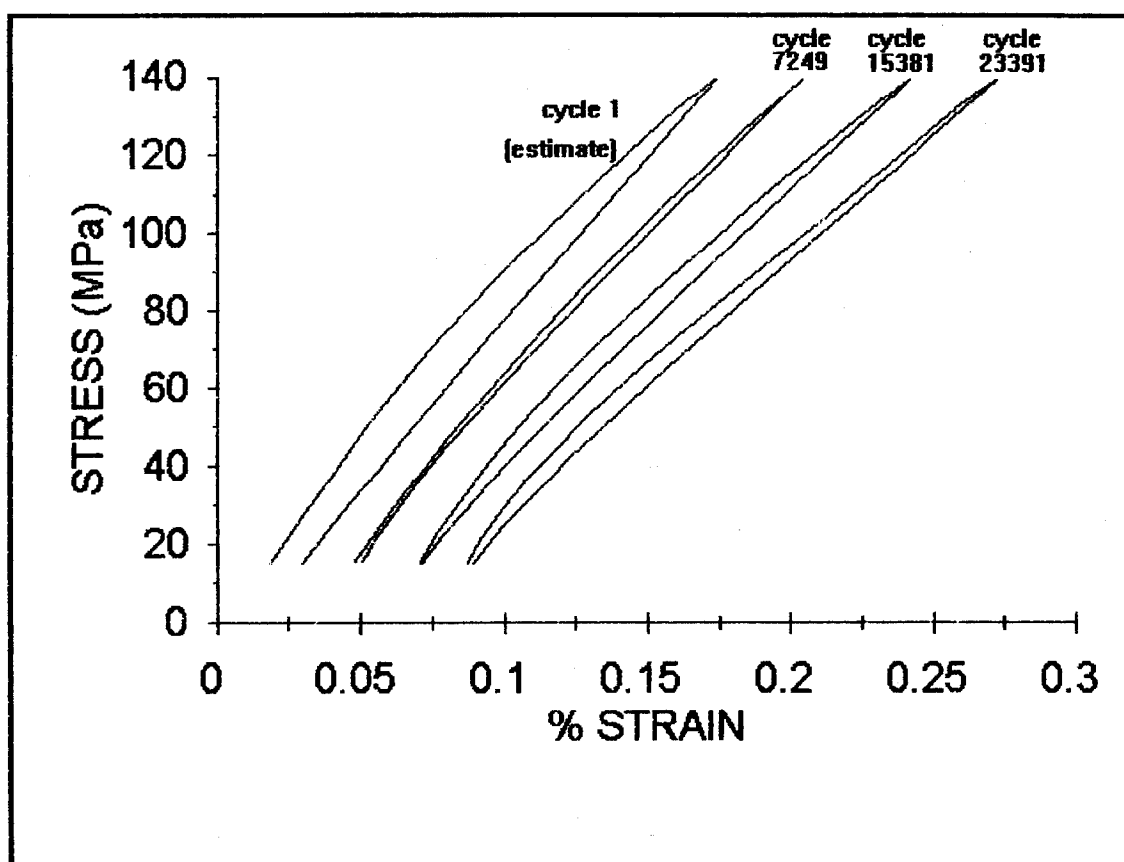
Figure 4-13 140 MPa Unnotched Stress Strain Curves

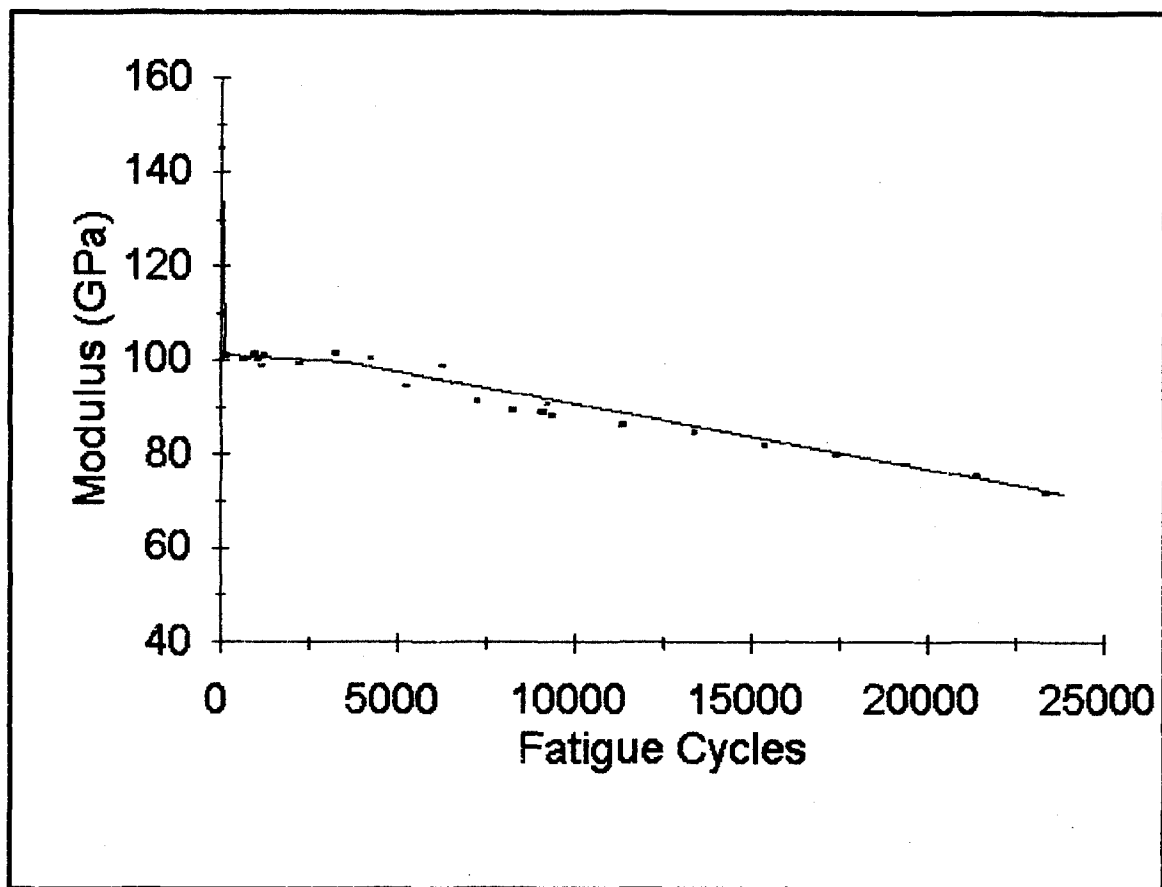
Figure 4-14 140 MPa Unnotched Modulus Reduction

Figure 4-14 shows the modulus reduction over the life of the test. This is further evidence of the microstructural damage taking place during the test. An initial modulus reduction of 31% was observed. This 31% first cycle modulus degradation to 100 GPa correlated exactly with the Young's modulus predicted by projecting a line from the origin to the 140 MPa stress level of the monotonic tensile test stress-strain curve. At this stress level, as opposed to higher fatigue stress levels, the modulus behavior assumed a slightly different nature. The initial cycle again produced modulus

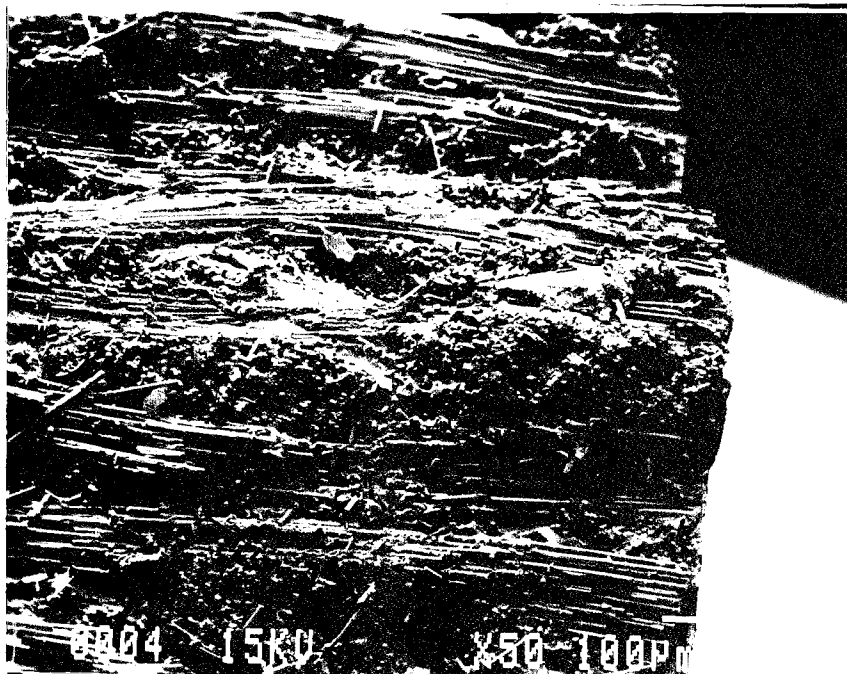
Figure 4-15 SEM Photomicrograph of Failure Surface at 45° Angle, 140 MPa Unnotched Test, 50X

A scanning electron micrograph of the fracture surface of this test is presented in Figure 4-15. This surface displays the same damage mechanisms as noted in previous tests; however, reduced fiber pull-out is also evident.

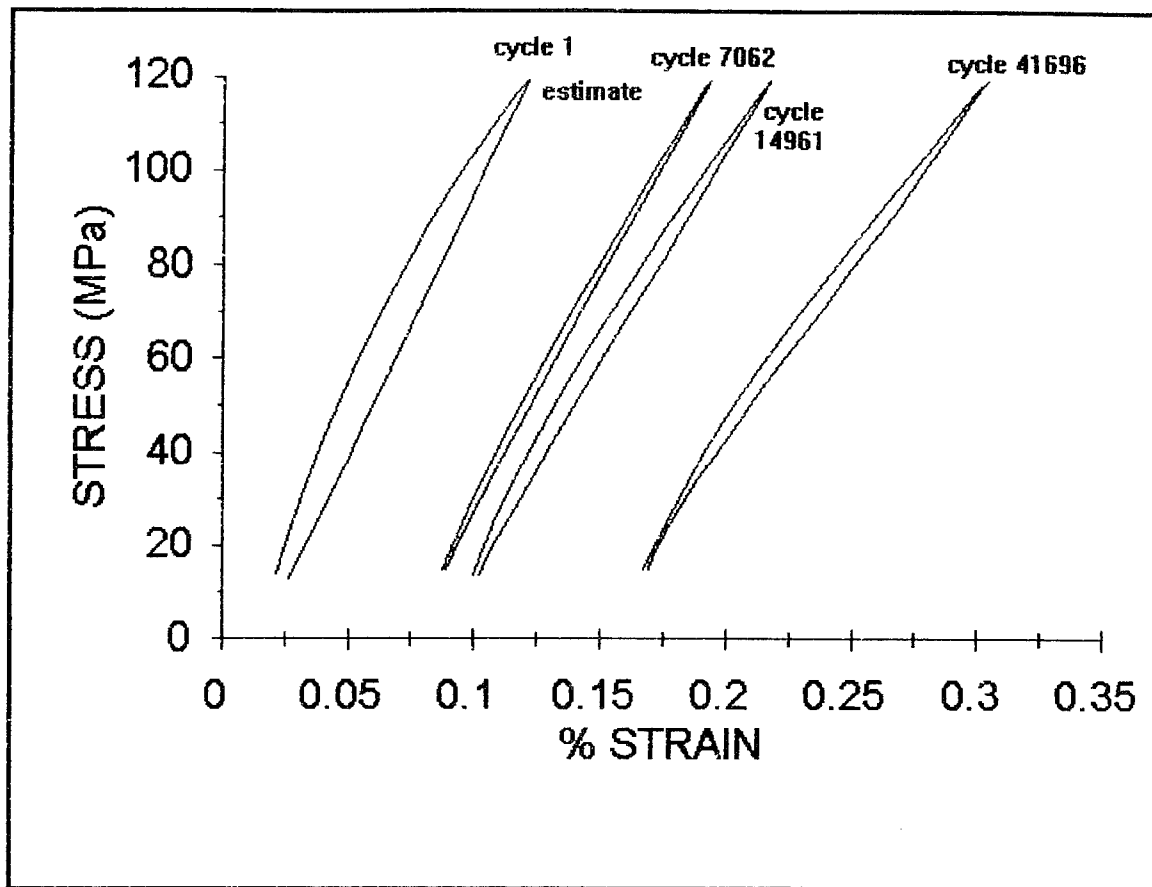
Figure 4-17 120 MPa Unnotched Stress-strain Results

The next lowest stress level of unnotched fatigue test was the 120 MPa test. It cycled 44,041 times before failure. A magnified view of the fracture is shown in Figure 4-16. The stress-strain curves of this test are plotted in Figure 4-17. This figure shows stress-strain response at four specific cycles of the test. This test had the most linear stress strain curves with the least hysteresis during the early cycles. The specimen showed almost completely linear response at cycle two with very little hysteresis and very slight nonlinearity. As the test progressed, however, hysteresis and

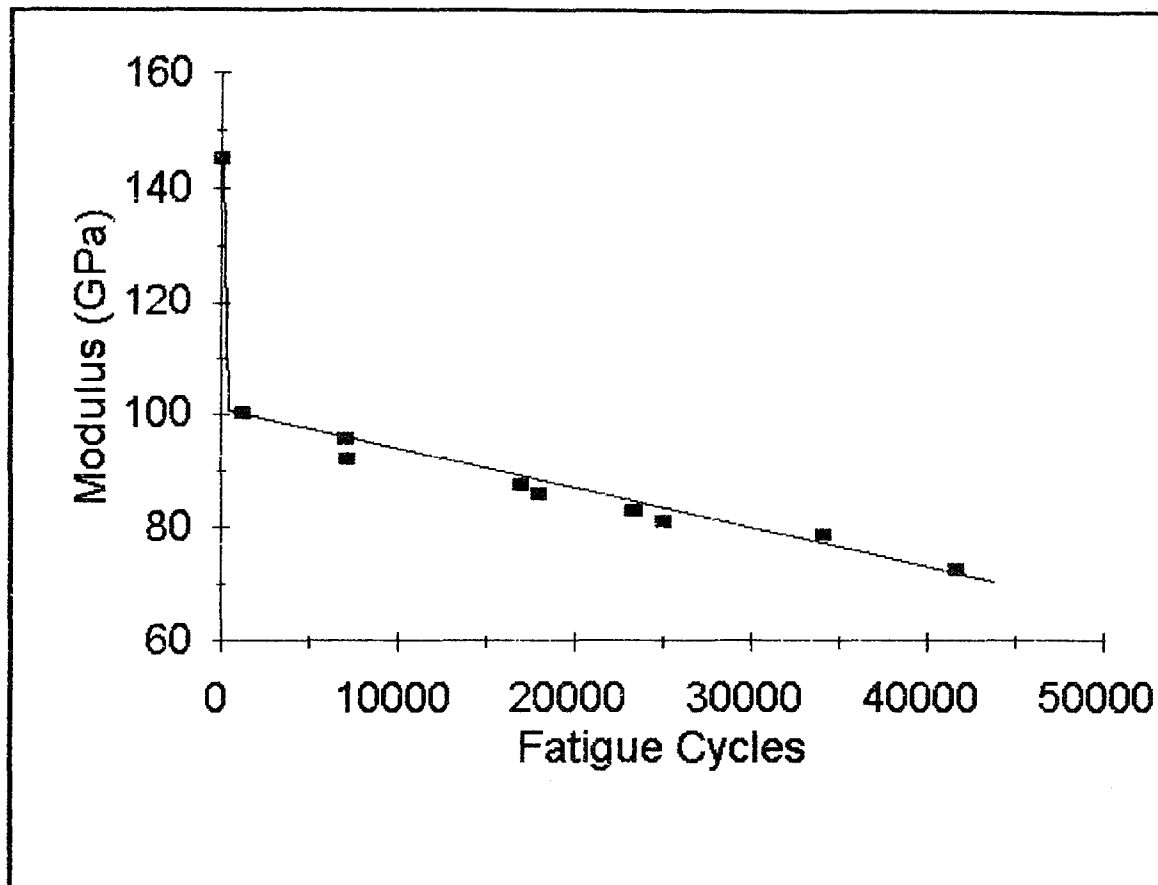
Figure 4-18 120 MPa Unnotched Modulus Reduction

Figure 4-18 shows the modulus reduction over the life of the test. Note the 21% loss of modulus from 145 GPa in the linear region of the first cycle to an average value of 115 GPa exhibited during the cycling of the test. A low magnification micrograph of the fracture surface is shown in Figure 4-19.

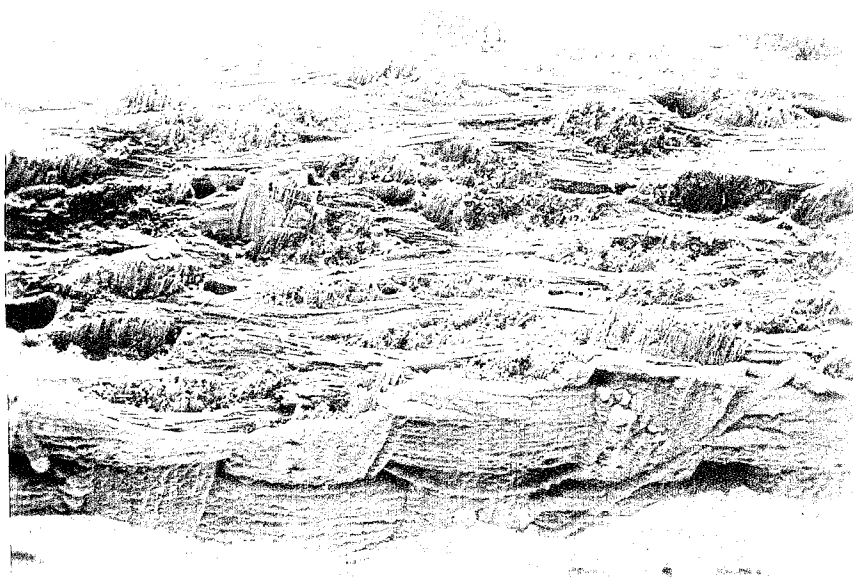
Figure 4-19 Scanning Electron Micrograph of Fracture Surface, 120 MPa Unnotched Test, 15X

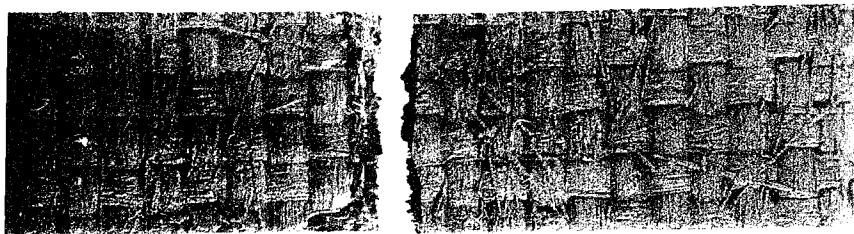
Figure 4-20 Fracture Surface, 110 MPa Unnotched Test, 7X

The lowest stress level of unnotched fatigue test was the 110 MPa test. It cycled 259,249 times before failure. A magnified optical micrograph of the fracture surface is presented in Figure 4-20. This specimen was the only unnotched specimen which had the failure in the center of the gage length.

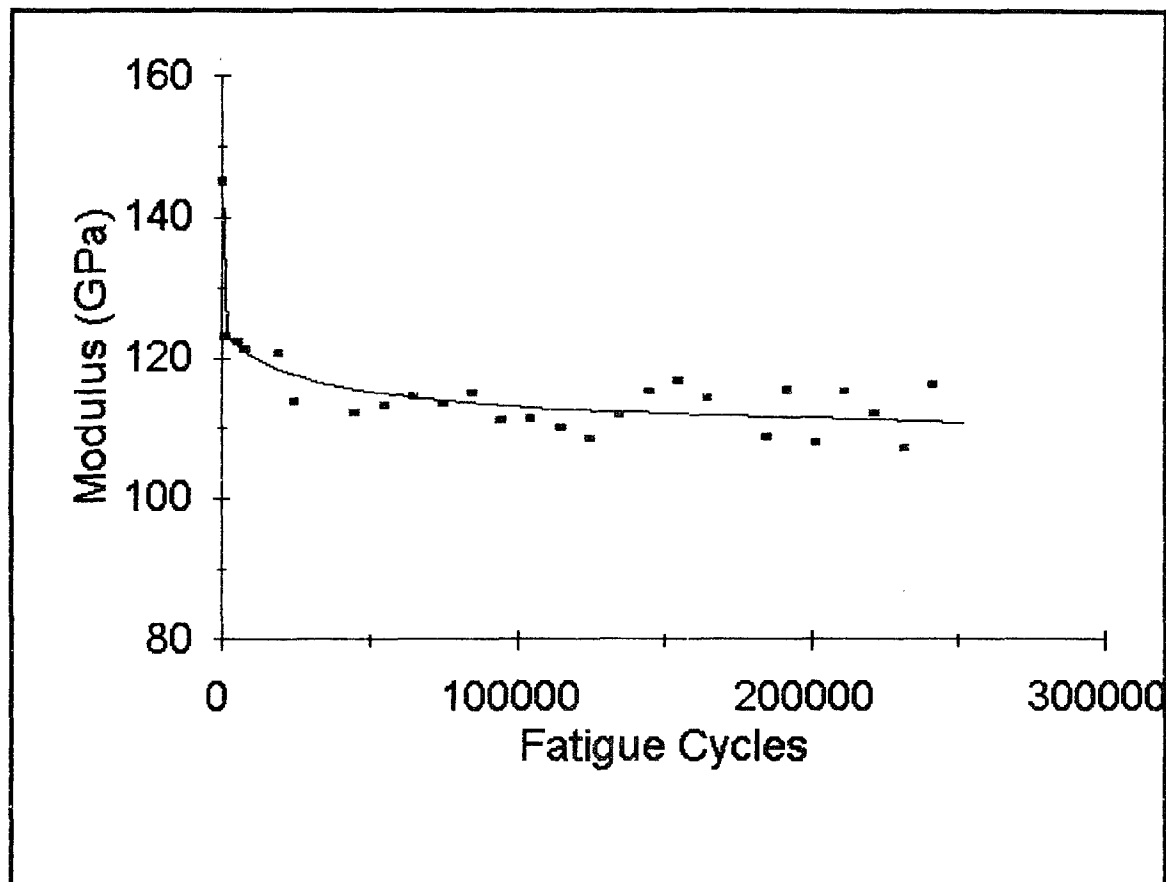
Figure 4-21 110 MPa Unnotched Modulus Reduction

Figure 4-21 plots the modulus reduction over the life of the specimen. Notice the modulus reduction of this test has a somewhat different character than previous unnotched tests. In the 110 MPa test, the modulus did not degrade below 110 GPa

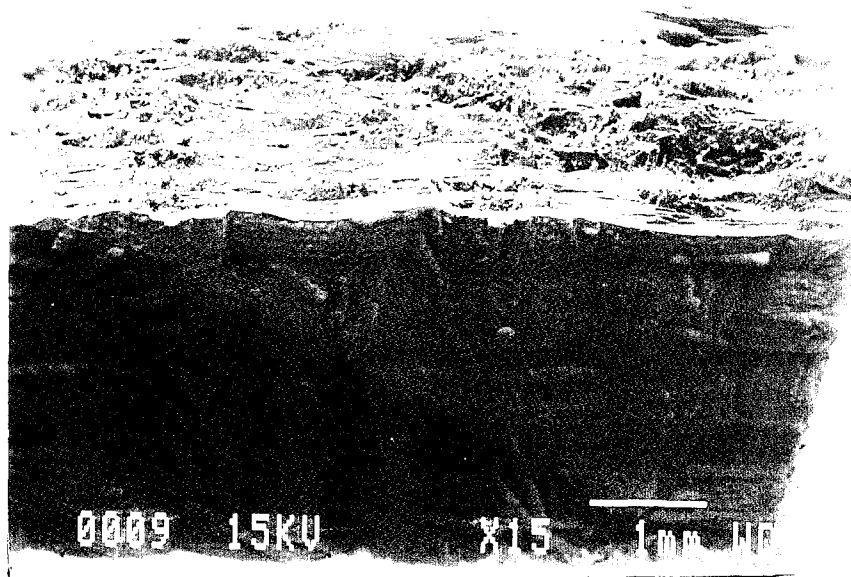
Figure 4-22 Scanning Electron Micrograph of Fracture Surface, 110 MPa Unnotched Test, 15X

before its failure. This behavior implies that the low stress fatigue damage mode has changed substantially from that of high stress fatigue. Figure 4-22 provides a 45° angular perspective view of this specimen's fracture surface and shows a marked contrast to the 210 MPa surface (Figure 4-8). The smoother
